Rapoo E6700 Bluetooth Touch Keyboard Teardown

This 'guide' shows that it is NOT possible to repair a damaged USB connector on this device.

Written By: Thomas Widmaier

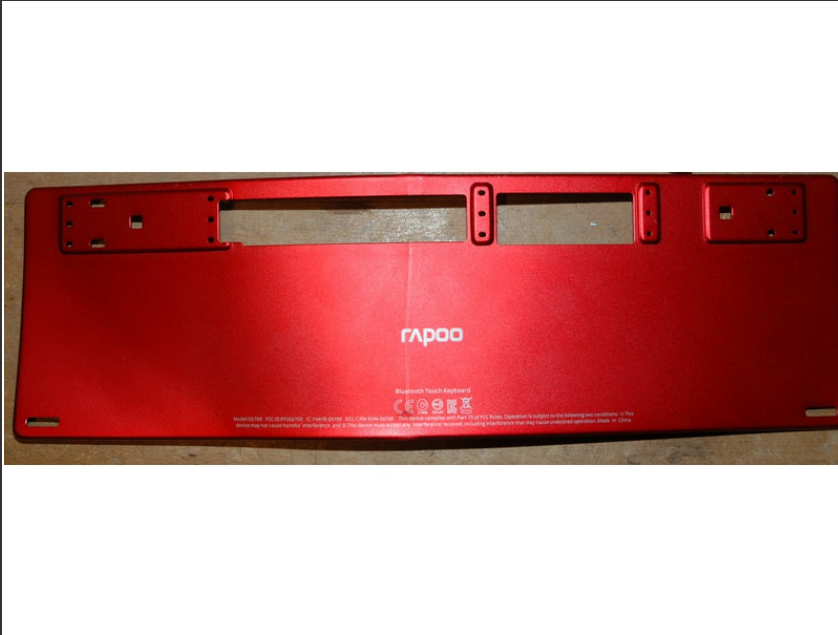
Step 2

- I tried to get access to the damaged USB connector, but the bottom cover that contains the main PCB is held in place by screws not from the outside but the inside.
- So I broke off the bottom cover to repair the connector, but then you cannot connect back the flex connectors to the keyboard.
- Maby we can separate the keyboard from the aluminium housing ?

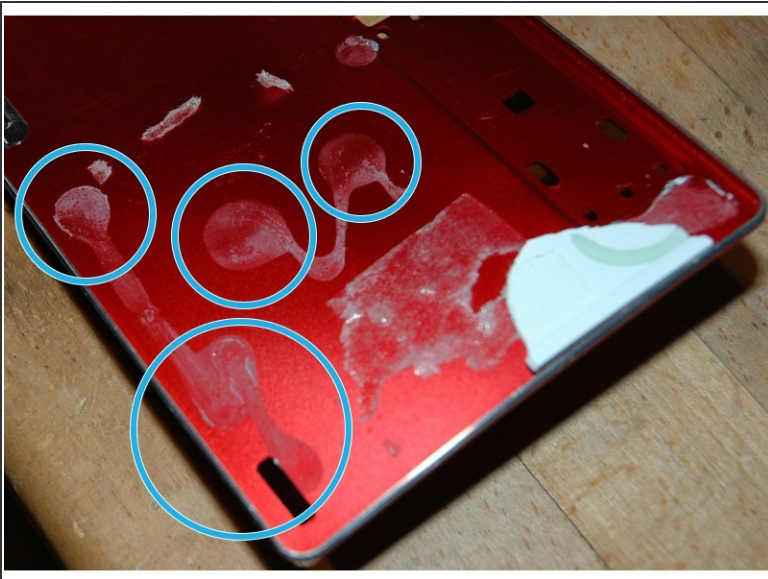
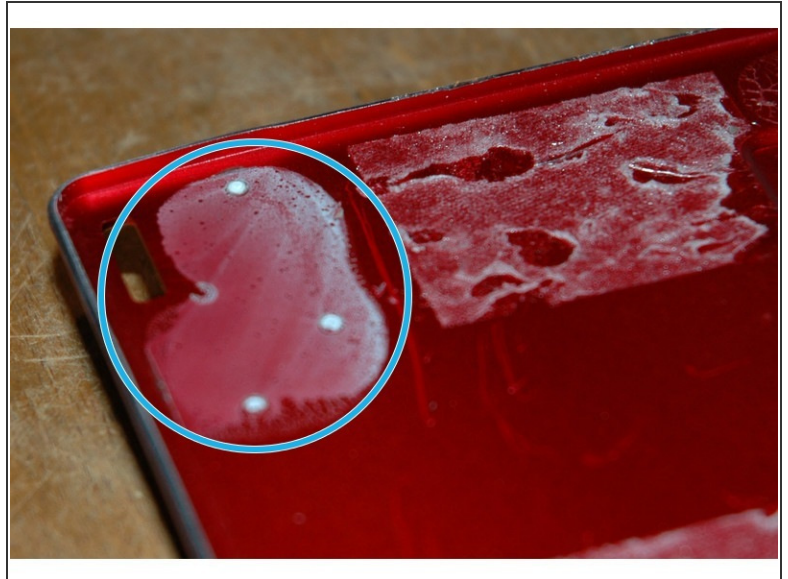
Step 3

- Well for those who try to get the keyboard off, someone has developed superglue.
- Yes you heard it, not just sticky double sided tape, also superglue applied in the marked areas.

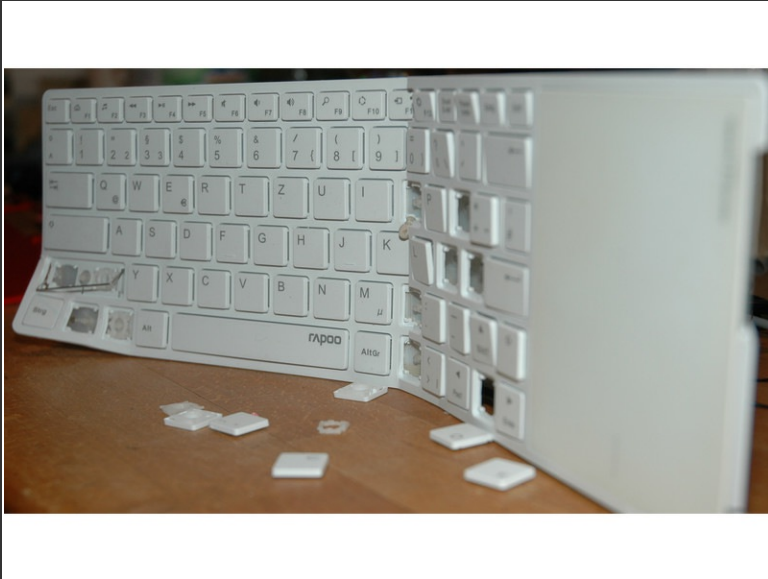
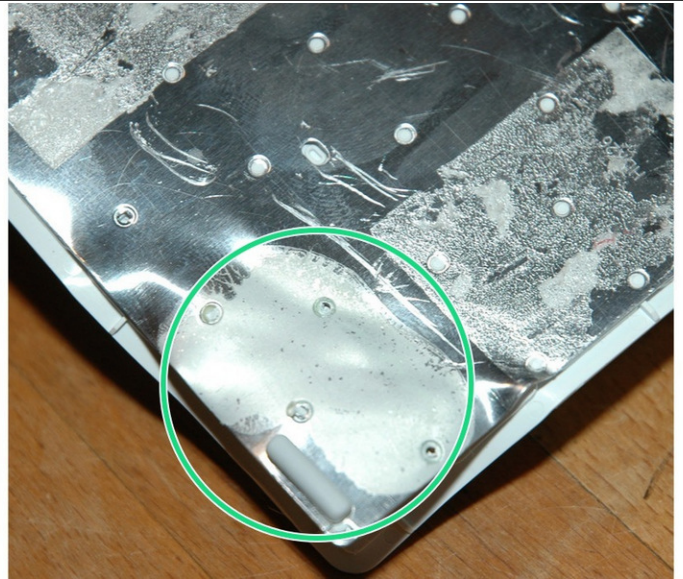
Step 4

- Here's the keyboard after 1 hour trying to separate the parts.
- And another view of the superglue residuals on the keyboard side.
